NASA TN D-2884

DEVELOPMENT OF A HEMISPHERICAL METAL DIAPHRAGM FOR SINGLE-CYCLE LIQUID-METAL POSITIVE EXPULSION SYSTEMS

By Sol Gorland

Lewis Research Center Cleveland, Ohio

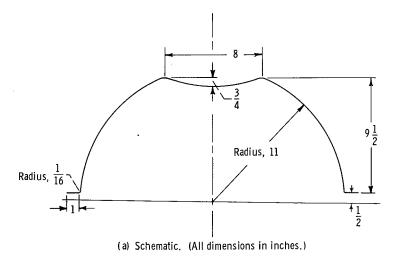
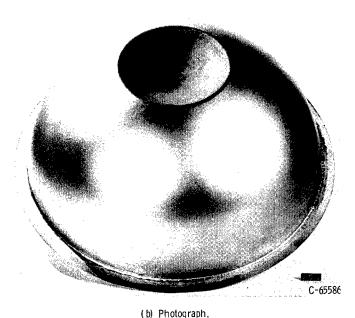
Figure 5. - Final segmented hemispherical diaphragm. Configuration C.

Configuration C was essentially another modification of configuration A. It consisted of removing the 1-inch cylindrical section and 1/2-inch of the hemispherical section of the diaphragm as shown in figure 5(a). A new 1-inchwide flange was then welded to the original material (to replace the integral flange of configurations A and B) so that the diaphragm could be clamped in the containment sphere. The flange was silver soldered to waterproof the joint as seen in figure 5(b). Configuration C was slightly less than a hemisphere and is actually a "segment" of configuration A. Two 0.016-inch-thick configuration C diaphragms were fabricated. Figure 5 shows a photograph of a configuration C diaphragm. Although configurations A and B were slightly different, figure 5(b) is typical of the diaphragms and clearly shows the polar indentation common to all.

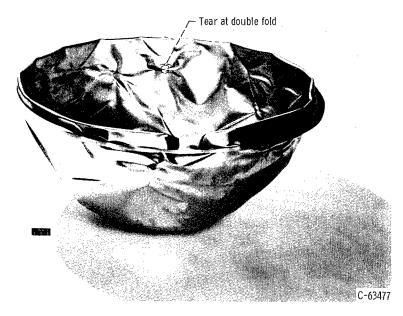
had continued, failure of the diaphragm would have occurred because of the severe twisting action, so the direction of expulsion was again reversed until approximately 85 percent of the original volume was displaced. The diaphragm developed a leak at approximately 70 percent expulsion, but since this was a shakedown run it was decided to continue the test beyond initial failure to study the deformation process. Upon removal, the diaphragm was found to have torn at one of the double folds. Figure 9 shows the first diaphragm after removal from the containment sphere: the tear at the double fold is circled.

Figure 9. - Diaphragm configuration A at end of test 1 (85 percent total expulsion tear occurred at 70 percent expulsion).

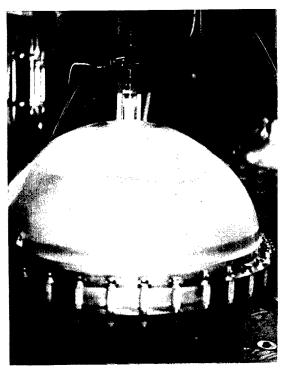
The corrugated hemisphere initially deformed very uniformly as shown in figure 10(a). It then began to deform on one side until the first or upper corrugation was reached. As seen in figure 10(b), it appeared that the material would easily roll over the corrugation, but cornering occurred in the corrugated area (fig. 10(c)). Columns formed in the corrugated areas (fig. 10(d))

(a) Initial deformation of corrugated diaphragm (5 percent expulsion) .

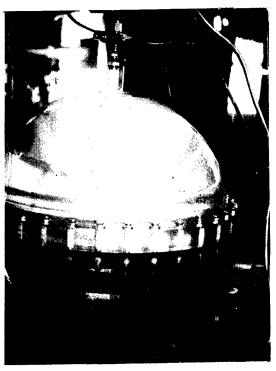
(b) Deformation nearing first corrugation (25 percent expulsion) .

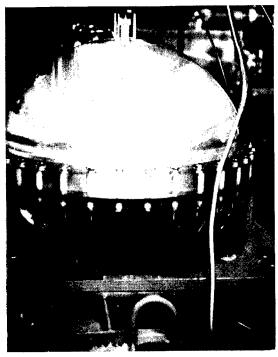
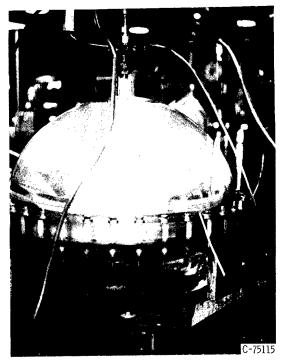
(c) Cornering effect in first corrugation (35 percent expulsion). (d) Column formation in first corrugation (50 percent expulsion). Figure 10. - Progressive deformation of diaphragm. Configuration B; test 4; 0.010-inch-thick diaphragm; flow rate, 205 to 235 pounds per hour.

supporting the hemisphere on that side until deformation was symmetrical. The second corrugation then became the starting point for the double fold phenomenon seen in figure 10(d). When this condition was attained, nearly the entire surface within the first corrugation seemed to double fold at once. Six double folds occurred almost simultaneously, all of which were larger than in the previous hemispheres. Three of these double folds produced tears at the failure point of 60.2 percent expulsion.

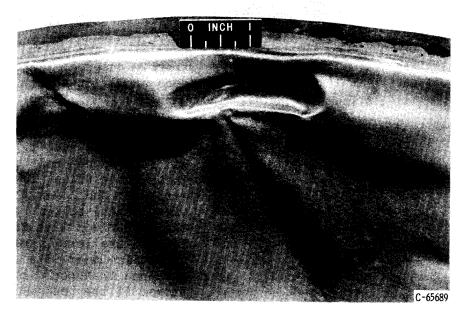
Figure 11. – Fully formed double fold in diaphragm configuration C after completion of expulsion cycle, 0.016-inch-thick diaphragm (95 percent expulsion, test 7).

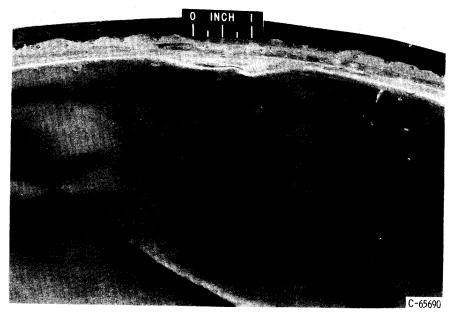
Figure 12. - Double fold at flange joint in diaphragm configuration C after completion of expulsion cycle, 0.016-inch-thick diaphragm (95 percent expulsion, test 7).

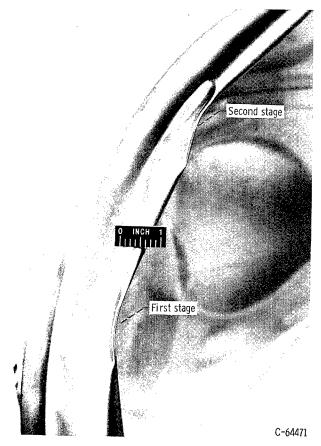
The third expulsion test again attempted to get motion pictures and also run the test at a higher flow rate. Failure again occurred at a double fold, the formation of which was similar to that for the other lower flow rates. The test was stopped when a hole developed in the diaphragm at an expulsion of 63.4 percent. Failure occurred earlier in the expulsion cycle than previous tests at lower flow rates. Films of this test clearly showed the method of deformation and the double fold phenomenon, which caused failure. These films aided in the visual analysis of the problem of diaphragm failure.

Figure 13. - Progressive stages of double folds in diaphragm. Configuration A; test 3.

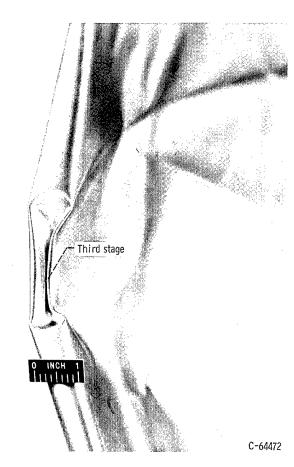
Figure 14. - Fully formed double fold in diaphragm. Configuration A; test 3.

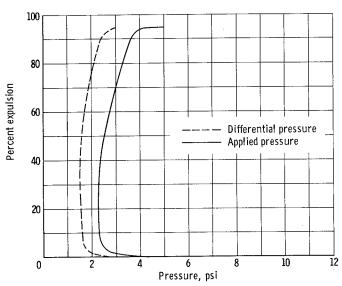
Figure 15. - Typical percent expulsion against pressure.

The pressure and deformation characteristics of the diaphragm can be discussed in a general manner since all the diaphragms performed similarly in this respect. A curve of percent expulsion plotted against applied and differential pressure, which was typical for all the diaphragms tested is shown in figure 15. After the initial deformation, the applied pressure decreased rapidly during the first 2 percent expulsion. The deformed area was increasing at a rate such that the load per lineal inch on the perimeter of the deformed surface was nearly constant with the decrease in applied pres-Typical deformation up to this point would appear as in figure 7(a). The arch-type bulges formed during deformation give strength to the diaphragm and when one of these buckled (at approximately 5 percent expulsion), a sharp pressure drop resulted. Decreased structural strength and the larger deformed area allowed the diaphragm to deform at an increased rate, thus increasing the Typical deformation at flow rate. this point would appear as it does in figure 7(b) (p. 7). Deformation continued at essentially constant pressure until approximately 40 percent expulsion, when the factor of increased force necessary to roll the material over itself overcame the increase in deformation area and the applied pressure began to increase. As shown in the curve of figure 15, this gradual increase in pressure continued until approximately 95 percent expulsion, if failure did not occur. Beyond approximately 95 percent expulsion, a
